Business Continuity of Water Works and Sewage Administrations during the Kahramanmaras Earthquake

Selcuk TOPRAK*, Emel SADIKOGLU*, and Oguz DAL*

Abstract

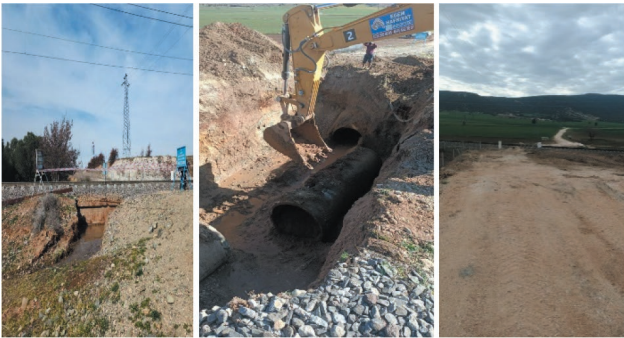
Drinking water for Gaziantep city primarily comes from three sources: Duzbag Stream intake, Mizmilli Wells, and Kartalkaya Dam. While the amount of water from each source can vary, the majority is supplied by Duzbag. Large diameter transmission pipelines are used to transport the water to the city. After the earthquake, there was damage and several issues related to both the water sources and the transmission pipelines (**Fig. 2**). Some of the damage was due to fault crossings, but there was also damage caused by strong shaking. For example, the Duzbag water transmission pipeline, with a diameter of 2,600 mm, was damaged by a surface fault rupture. The fault experienced approximately 4.5 meters of left-lateral strike-slip movement, with no vertical displacement observed.

Fig. 2 Kartalkaya Pipeline Damage Repairs (Courtesy of GASKI).
