A Business Continuity Perspective on Losses and Recovery Processes in Organized Industrial Zones After 2023 Kahramanmaras Earthquakes

Ceren OZER SOZDINLER^{*,**}, Selcuk TOPRAK^{*,**}, Ahmet Anil DINDAR^{*,**}, and Bulent AKBAS^{*,**}

Abstract

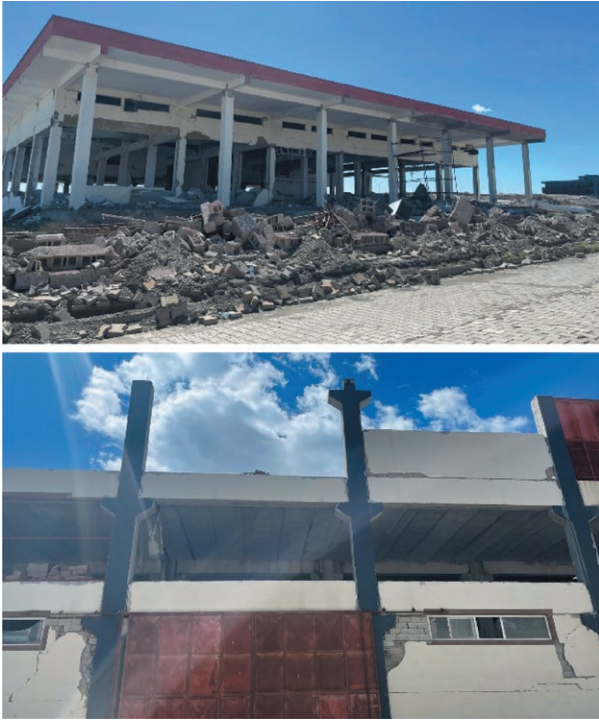
Turkoglu is one of the most damaged OIZs in the disaster region. During the earthquake, one prefabricated building under construction, an idle reinforced concrete building (roof trusses fell off) and a storage unit of a facility were destroyed. While five facilities were found to be slightly damaged, the remaining facilities were found to be moderately and heavily damaged and in urgent need of demolition (**Fig. 3**). After the damage assessment studies, there was a change from heavy

Fig. 3 Structural damage at precast reinforced concrete buildings in Kahramanmaras Turkoglu OIZ due to Kahramanmaras Earthquakes.

to moderate damage in some facilities that used their right to object to the decision. The court processes are continuing in some facilities to date.

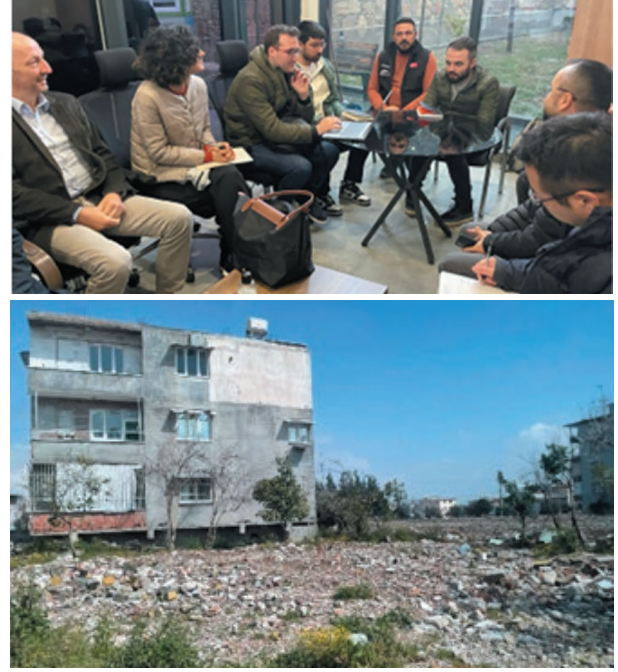
Fig. 5 Meeting with HATSU officials and a view of earthquake damage in Hatay.

There was slight earthquake damage to the dam and water purification facilities, while serious damage occurred in the wells. Water service gradually started to be provided 5 days after the earthquake.
