Post-Earthquake Condition of Lifeline Systems Following the Kahramanmaras Earthquakes

Abstract

Key words: Pipelines, Disaster, Earthquake damage, Lifeline systems, Water transmission

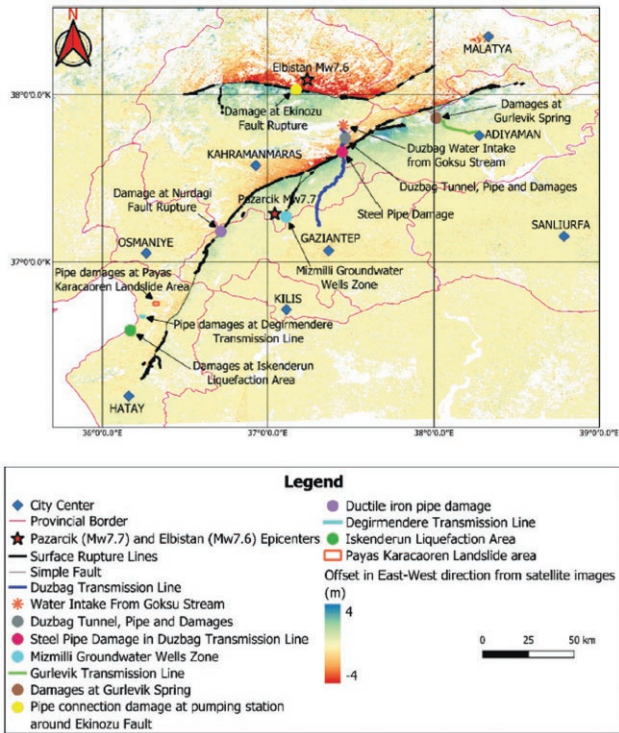
To further illustrate the extent of the impact, **Fig. 1** provides a general overview of the water transmission systems, and the various types of damage observed following the earthquakes². The map points out the damage locations, fault lines, and key system points, including water intake and transmission lines affected by fault ruptures, landslides, and liquefaction areas. Additionally, the figure includes data on east-west offset measurements derived from satellite images, allowing for a clearer understanding of the fault movements. This visualization helps in understanding the impact of seismic events on critical lifeline systems and underscores the importance of reinforcing vulnerable areas to improve disaster preparedness and resilience.

Fig. 1 General Overview of the Damages and Water Transmission Lines².

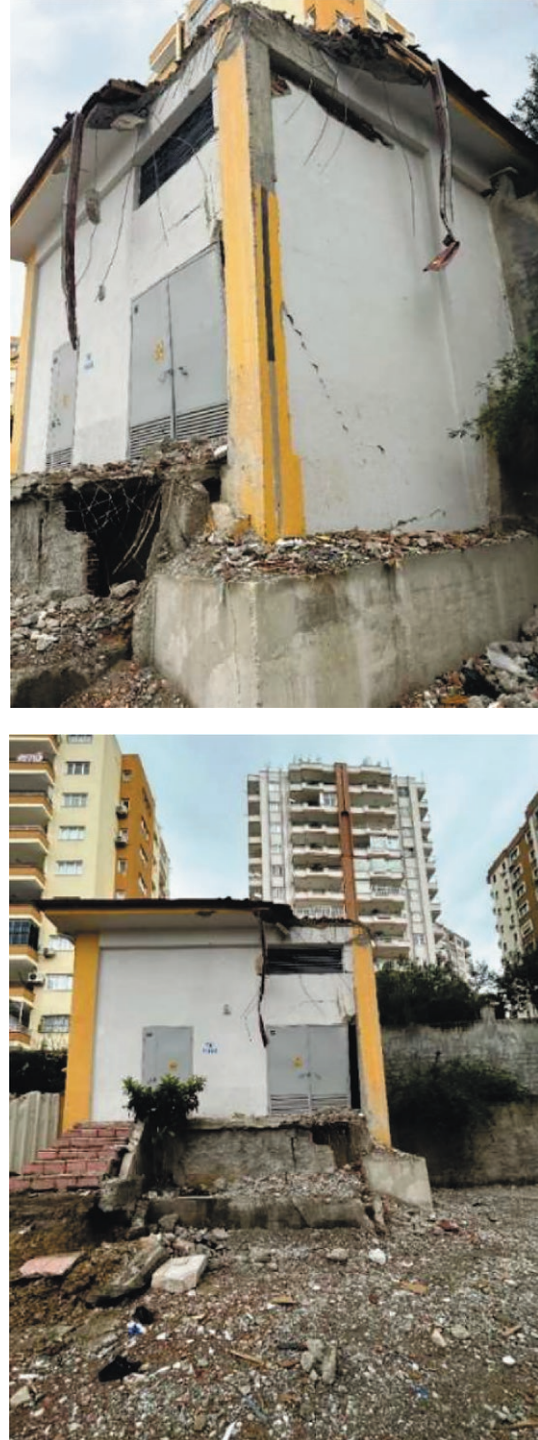
The total damage to the lifeline systems, including electricity, natural gas, petroleum, and fuel systems, was estimated at 13.8 billion TL, with the most significant impact in Hatay, Malatya, Kahramanmaras, and Gaziantep. Transformer stations and other electrical systems sustained significant damage, as illustrated in **Fig. 2**. In the transportation sector, the earthquakes caused landslides, bridge and tunnel damages, and highway cracks.

Fig. 2 Adana City Transformer Center TR184 Damage¹⁷⁾.

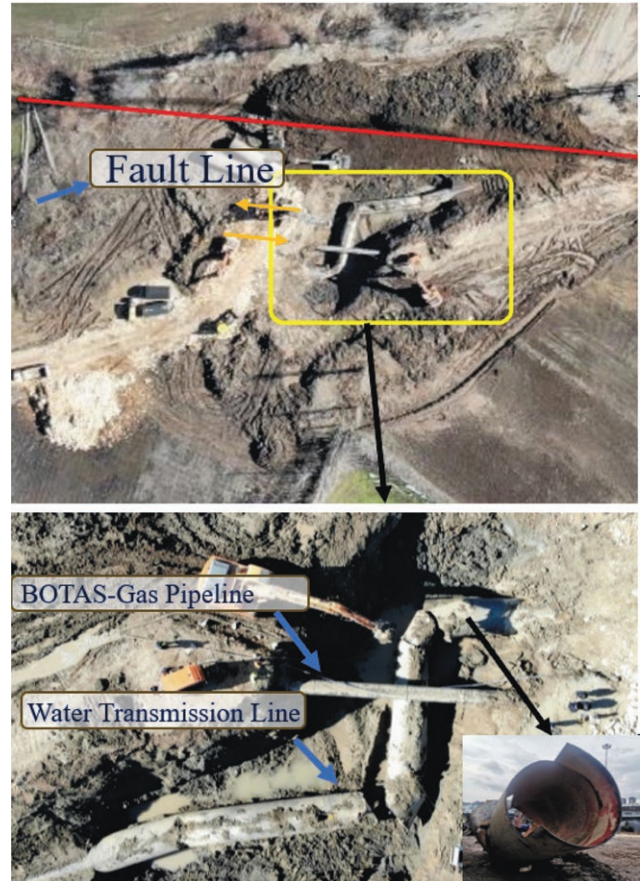
In the first week, the Duzbag line experienced power outages and structural damage in the tunnel and at the fault line intersection (Fig. 3), leading to a month-long delay in its reuse.

Fig. 3 Intersection of BOTAS Petrol and Gaziantep Main Water Transmission Pipeline with Fault Rupture²⁾.

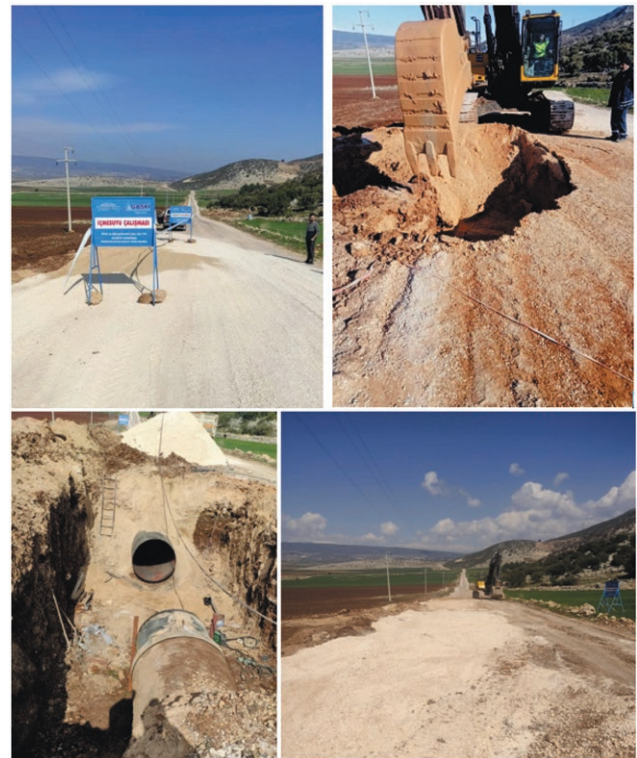
Kartalkaya PSC line experienced failures and severe damage to pumping facilities, leading to its discontinuation (Fig. 4). The steel transmission line, however, resumed supply 1-2 days post-earthquake. The Mizmilli line remained mostly intact but had pump station damage and water turbidity due to tectonic movements. Water supply resumed in 2 days, but the water was only usable for purposes other than drinking. Turbidity issues persisted despite efforts to wait it out. In the non-central districts, well water was primarily used. Nurdagi faced energy problems, resolving water supply by the 4th day with generators. Nurdagi and Islahiye had pipe damage near fault lines, while the other districts had no major issues.

Fig. 4 Kartalkaya Pipeline Damage Repair Operations.

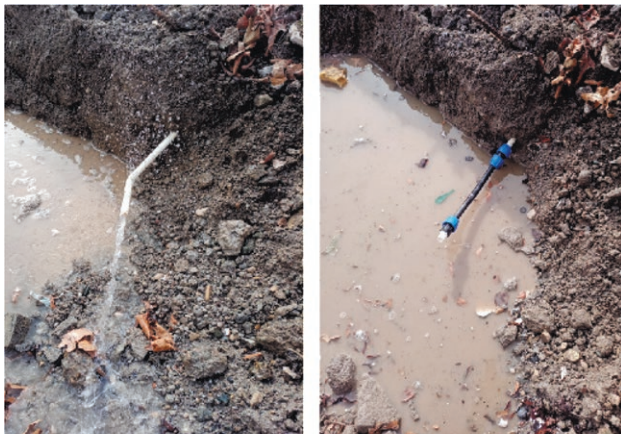
a) Blinding Operations at Destroyed Buildings

Fig. 5 Repair Works Done by KASKI Teams (Courtesy of KASKI).

Most earthquake damage occurred in Dulkadiroglu. The lifeline system renewal will begin in Kanlidere, the city’s oldest neighborhood. KASKI plans to use ductile iron pipes for diameters over 300 mm and polyethylene pipes (PE) for smaller diameters. Before the earthquake, network pipes in Afsin and Goksun were replaced with PE pipes, resulting in fewer issues. Inspections in Turkoglu Sekeroba revealed that a 160 mm PE pipe stretched almost a meter along the fault line but continued to supply water. KASKI also began blinding water supply lines to buildings destroyed by the earthquake (Fig. 5).

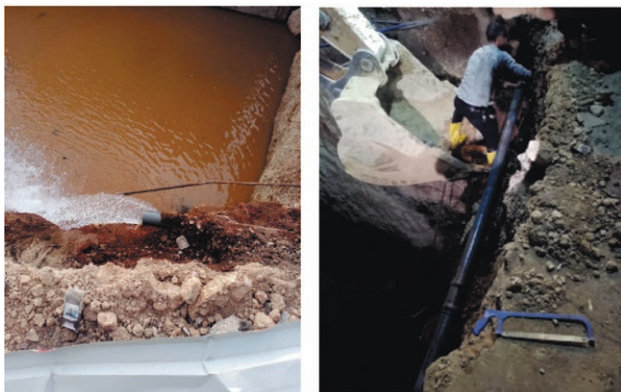
b) Operation of Repair of PVC Pipe

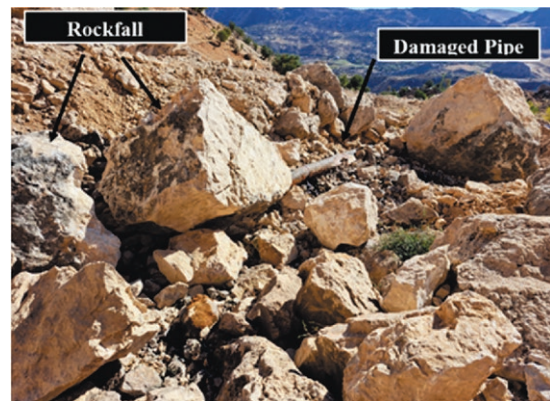
Adiyaman’s water supply sources, including Gurlevik, Havseri, Tut-Medetsiz, and Koru-Palanlı, were heavily impacted. The Gurlevik steel water pipeline suffered significant landslide damage, recording 25 serious issues along the line (Fig. 6). The city center faced numerous distribution system damages, necessitating around 100 daily repairs.

Overall, the damages in Adiyaman resulted from earthquake-induced landslides and lifeline deficiencies, including the lack of implementation of earthquake-resistant systems, with primary causes being faulting effects, liquefaction, lateral spreading, and aging systems.

Fig. 6 Pipe Damages at Gurlevik Spring, Adiyaman²⁾.
