北海道日高・十勝地方の豪雨災害概要

Outline of Flood Disaster in the Districts of Hidaka and Tokachi, Hokkaido

Outline of the severe disaster in the Hidaka District, Hokkaido

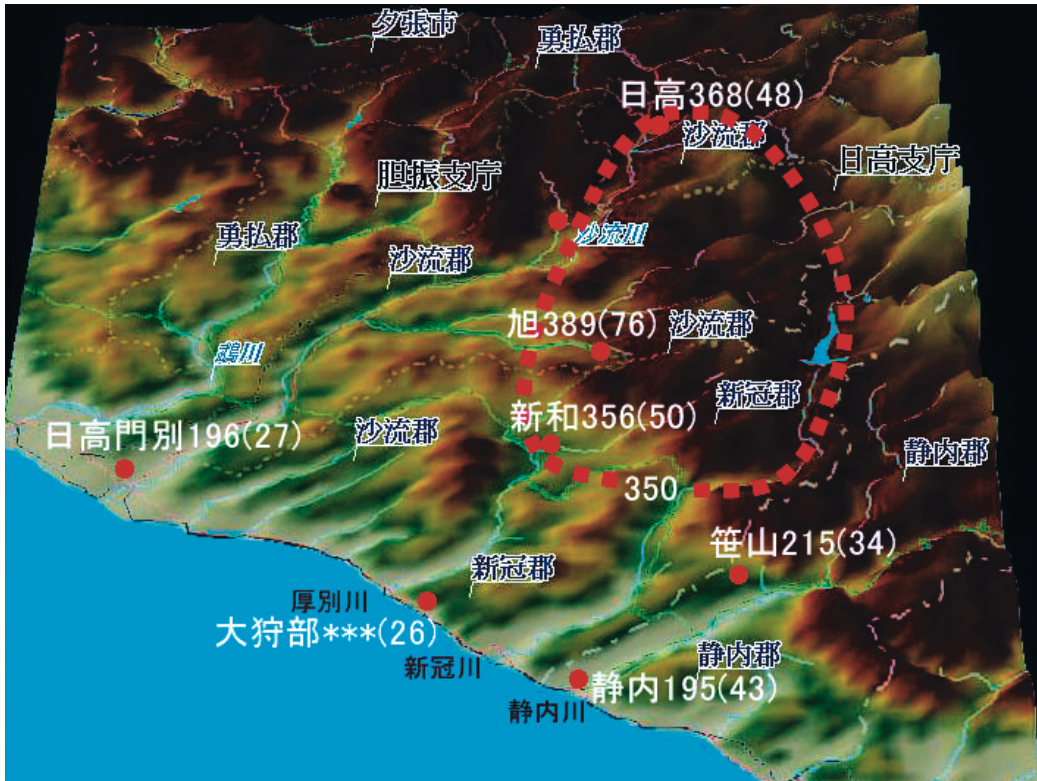
図 1 2003 年 (平成 15 年) 8 月 8 - 10 日に掛けての台風 10 号の影響による北海道日高地方の雨量分布. 数字は 8 月 7 日 18 時から 10 日 4 時の間の総雨量(mm), () 内数値は最大時間雨量

Fig. 1 Distribution of rainfall caused by Typhoon No. 10 on Aug. 8-10, 2003. Numbers are the total rainfall amount from 18:00 Aug. 7 to 4:00 Aug. 10 and the numbers in parenthesis are maximum hourly rainfall amount.

日高地方は台風10号の接近により、9日3時～5時、13時～16時および21時～翌日の1時に掛けて大雨が

もたらされた(図1、口絵2参照)。特に、第3波目の大雨は平取町の旭で最大60分雨量91mmを記録し、近年にない大洪水が発生した。この時、町村役場や道路等の管理事務所が位置する海岸沿いでは強い雨は峠を越していた。沙流川や厚別川の山間地域では第1波および第2波の大雨により、表層土壌は相当湿潤な状態に有ったと推測される。そこに記録的な豪雨もたらされ、流域に保水しきれない大部分の雨水が短時間の内に河川に流出したと推測される。また、各地で土砂崩壊や土石流が発生し、多量の土砂と流木が生産された。それらは河川に流出し、護岸の浸食、川床上昇、流木による橋梁の破壊、橋上流での洪水位の堰上げ等を引き起こし、著しい洪水被害を発生させた。沙流川の二風谷ダムではおびただしい流木が流れ込み、流木の処理に多大な労力を費やした(口絵10参照)。その事が幸いして、下流域では流木による橋梁・護岸等の被害は比較的少なかった。一方、上流にダムの無い厚別川では流れ出た多量の流木により、橋梁や護岸が大きな被害を受けた(写真1参照)。

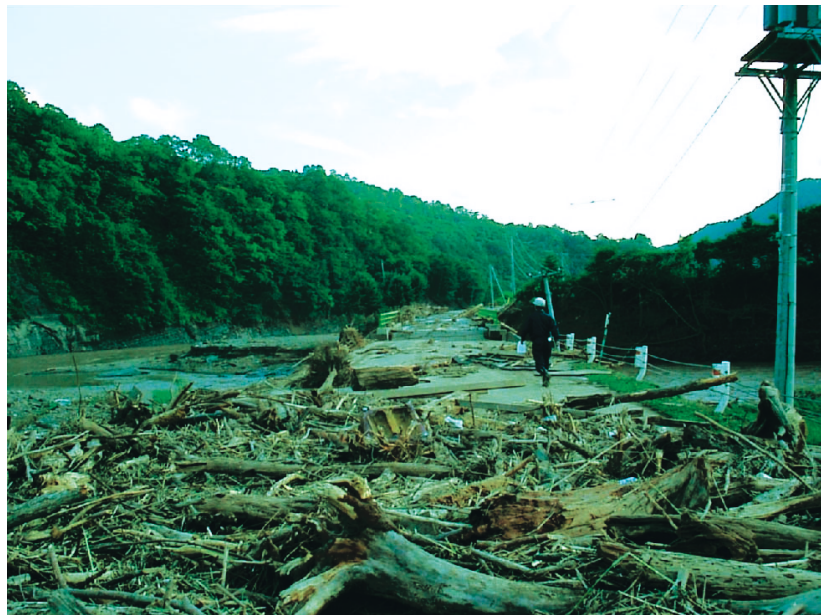
写真 1 厚別川の比宇川合流点付近の道道路比宇厚賀停車場線における洪水後の流木の散乱状況. 北海道庁提供 _ 台風被害状況資料 / 台風 10 号日高支庁管内の被害写真 (URL:www.pref.hokkaido.jp/soumu/sm-bsbou/typhoon-10/hidaka.htm)

Photo 1 Dispersion of driftwood over the hiukougatesiyaba road of the Hokkaido Government after the flood near the confluence of the Hiu and Appetsu Rivers (courtesy of the Hokkaido Government, URL:www.pref.hokkaido.jp/soumu/sm-bsbou/typhoon-10/hidaka.htm).

- (1) 孤立した集落の被災状況を早期に把握するための緊急時の情報伝達手段の確保・充実。
- (2) 道道の事前交通規制区域の強化。
- (3) 道路管理者による水位など河川情報の活用。
- (4) 河川上流地域の水位雨量観測施設の増設。
- (5) 関係機関との河川および道路関連情報の共有。
- (6) 緊急時の道路、河川等のパトロール体制の強化。
- (7) 流木により多くの橋が壊されたり、膨大な量の流木の処理に苦慮したことから森林保全および流木流出防止対策が必要。
- (8) 総合技術職の育成：道路と河川双方の知識と経験を備えた職員など。

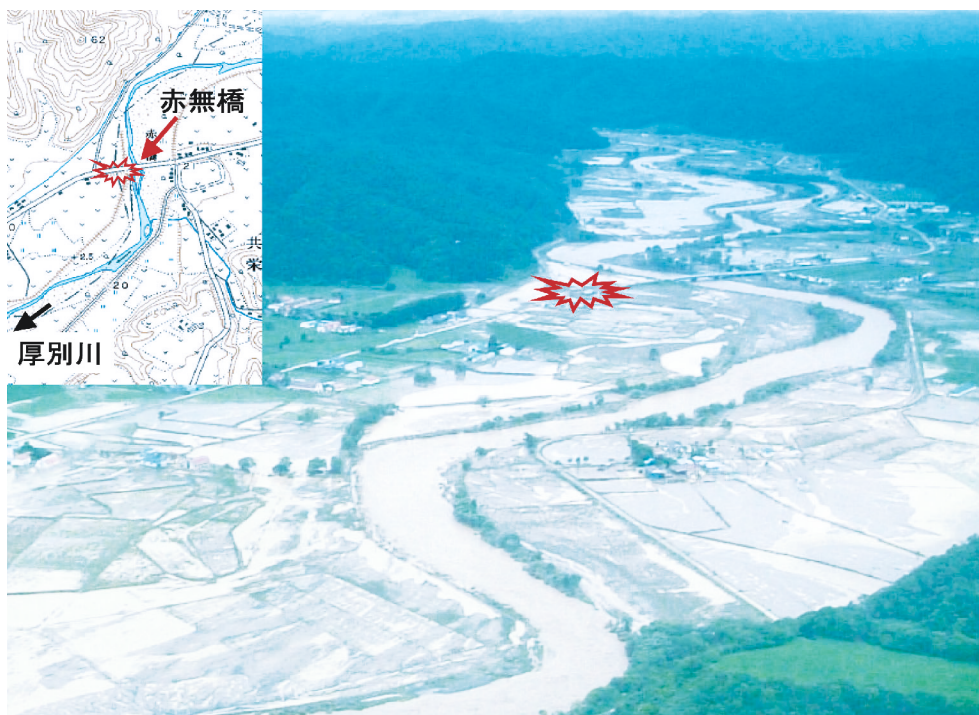
写真 2 新冠町共栄地区の厚別川沿いの氾濫源の洪水被害状況。ここで、5人乗せたワゴン車が洪水で流し、2人は救助されたが3人が亡くなった。北海道庁提供_台風被害状況資料/台風10号日高支庁管内の被害写真 (URL:www.pref.hokkaido.jp/soumu/sm-bsbou/typhoon-10/hidaka.htm)

Photo 2 Flood damage on the flood plain along the Appetsu River in Kyouei district of Niikappu Town. A van with five passengers was washed away by the flood. Two people were rescued but three were lost (courtesy of the Hokkaido Government, URL:www.pref.hokkaido.jp/soumu/sm-bsbou/typhoon-10/hidaka.htm).

北海道の日高・十勝地方では豪雨災害により、11名の死者・行方不明者が発生した。その内、10名は車の流失・落下に伴うものであった。日高地方の新冠町では国道の道路規制により、迂回路を取ったワゴン車が道道の厚別川に架かる赤無橋付近で浸水により立ち往生した(写真2参照)。携帯電話で消防署に救助を求め、助けを待つ内にそのワゴン車は5人を載せたまま洪水に流された。5人の内、2人は救助されたが、3人が行方不明となった。ワゴン車の他に一家3人が乗った乗用車が浸水し、立ち往生したが、浸水がひどくなり危険を感じたので車を放置し、膝上の浸水深の中を避難し、難を逃れていた。また、十勝地方の上士幌町では居辺川に架かる居辺橋への取り付け道路が洪水により陥没し、そこに通りがかったワゴン車とトラックが転落する事故が発生した(写真3参照)。このため、ワゴン車に乗っていた5人が死亡した。これらは深夜の非常時の道路パトロールのあり方や河川管理者と道路管理者間の相互の情報伝達や河川情報の共有等による早期の交通規制について改めて問題提起をした。

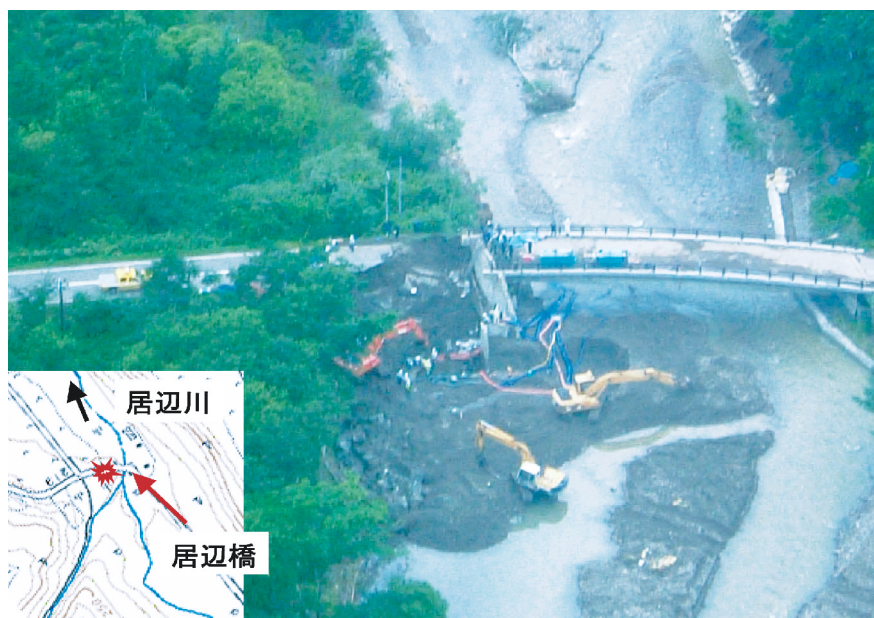
写真 3 上士幌町の居辺(おりべ)川に架かる居辺橋の左岸側道路の陥没状況。ここで、ワゴン車が転落し、乗っていた5名が川に流され死亡した。北海道庁提供_台風被害状況資料/台風10号十勝支庁管内の被害写真 (URL:www.pref.hokkaido.jp/soumu/sm-bsbou/typhoon-10/tokati.htm)

Photo 3 The fatal cave-in of the road leading to the Oribe Bridge over the Oribe River in Kamishihoro Town. A van carrying five people plunged into a hole in the road. They were washed away by flood (courtesy of the Hokkaido Government, URL:www.pref.hokkaido.jp/soumu/sm-bsbou/typhoon-10/tokati.htm).
