Effects of Kahramanmaras Earthquakes on Small Businesses and Factories

Abstract

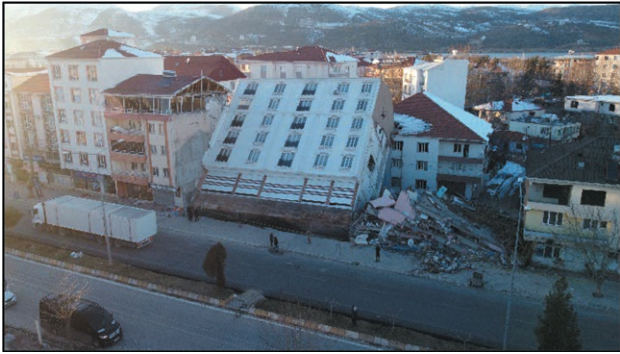
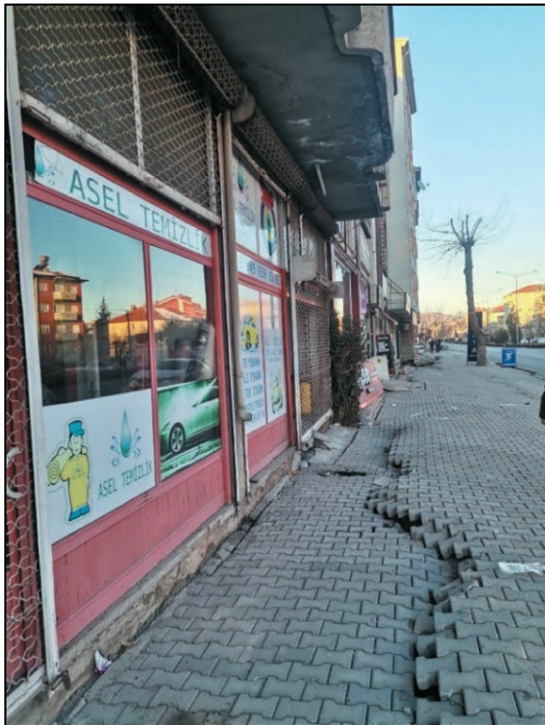
Fig. 2 Earthquake Damages in Golbaşı ⁴⁾.

Kahramanmaraş, where much of the destruction occurred, was densely populated with apartment buildings, often featuring retail stores and restaurants on the ground level. Following the earthquakes on February 6, which caused significant damage, 3,573 of the 4,055 temporary workplaces planned at 64 locations were delivered to tradesmen whose workplaces were destroyed or severely damaged. In addition to the heavily damaged buildings in Kahramanmaraş, approximately 3,000 workplaces were heavily damaged or destroyed in Adiyaman. To support the tradesmen affected by this destruction, the state took action to facilitate their return to commercial activities. Temporary markets were established in city centers, and container and prefabricated buildings were constructed to house bazaars and individual workplaces in both container cities and city centers. As a result, 1,526 workplaces have resumed business operations in 41 temporary markets established in Adiyaman. **Fig. 2** illustrates the extensive damage to workplaces in Golbaşı, a

a) Damaged buildings in Golbaşı

b) Foundation problems in Golbaşı

district of Adiyaman, caused by the earthquakes ⁴⁾.

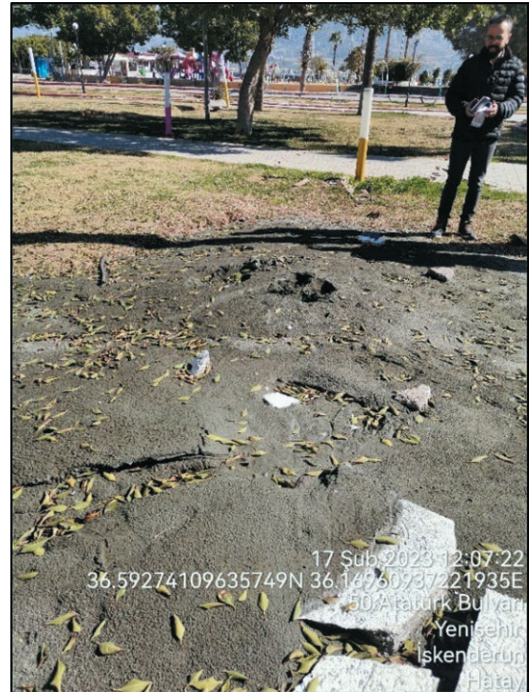
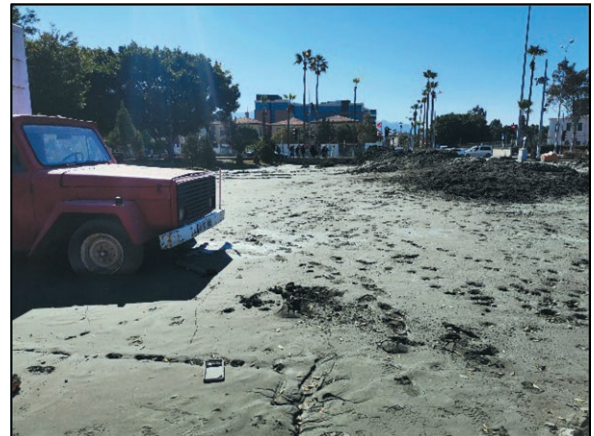
Fig. 3 Liquefaction Effects in Iskenderun ⁴⁾.

In the Iskenderun district of Hatay, significant liquefaction effects were notably observed, particularly along Atatürk Street (**Fig. 3**) ⁴⁾. The severity of the liquefaction resulted in extensive damage to numerous businesses situated on this street. Consequently, these businesses faced prolonged service suspensions, severely impacting the local economy

a) Sand boils

b) Liquefaction ejecta

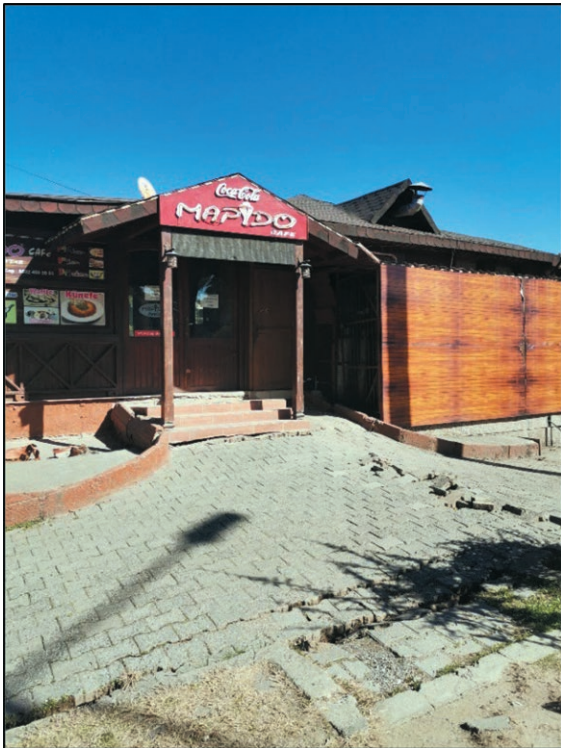
Fig. 4 Liquefaction Effect on Business in Iskenderun.

(Fig. 4). The aftermath of the liquefaction not only disrupted daily operations but also necessitated substantial efforts for recovery and reconstruction.

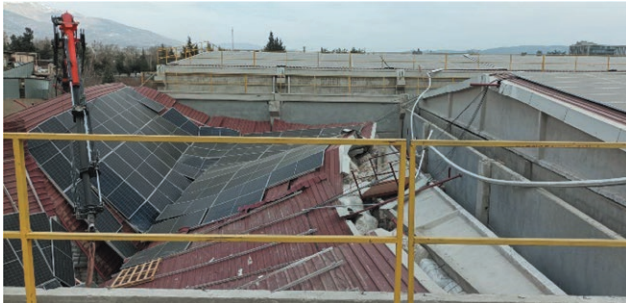
Fig. 6 Aral Textile Earthquake Damages.

Aral Textile, located approximately 1.5 km from Beydag Textile, was significantly more affected by the earthquake

(Fig. 6). Fig. 6a displays the damage to the roof of Aral Textile Factory, while Fig. 6b shows the damaged machinery inside the factory. Despite these challenges, the factory managed to produce 8 functional machines from the 12 damaged ones, allowing production to continue. Aral Textile resumed production approximately 9 months later.

a) Damaged factory roof

b) Damaged factory machine
