A Business Continuity Perspective on Losses and Recovery Processes in Organized Industrial Zones After 2023 Kahramanmaras Earthquakes

Ceren OZER SOZDINLER^{*,**}, Selcuk TOPRAK^{*,**}, Ahmet Anil DINDAR^{*,**}, and Bulent AKBAS^{*,**}

Abstract

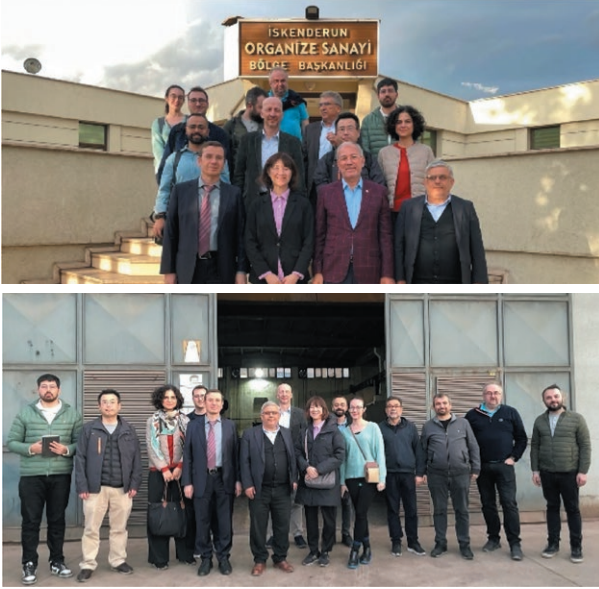
Iskenderun Organized Industrial Zone management was visited to discuss the problems experienced in the industrial facilities after the Kahramanmaras Earthquakes, the recovery process and the current situation (**Fig. 4**). There are 45 industrial facilities within Iskenderun OIZ where the majority of them were on iron and steel production as well as energy systems.

Fig. 4 Visit to Iskenderun OIZ management and an industrial facility producing metal.
